P.I.N. X051.59  
BRIDGE DECK EVALUATION REPORT

<u>Description:</u>	Grand Central Parkway over Winchester Blvd and Cross Island Parkway and Ramp "H" over Cross Island Parkway
<u>BIN:</u>	1065149 and 106514A
<u>GCP Reference Marker:</u>	1120 to 1124
<u>County:</u>	Queens
<u>City of:</u>	New York
<u>Region:</u>	11
<u>Feature Carried:</u>	Grand Central Parkway and GCP Ramp "H"
<u>Feature Crossed:</u>	Cross Island Parkway Winchester Blvd

# IN-DEPTH INSPECTION REPORT

**B.I.N. 1-06514-9 & 1-06514-A**

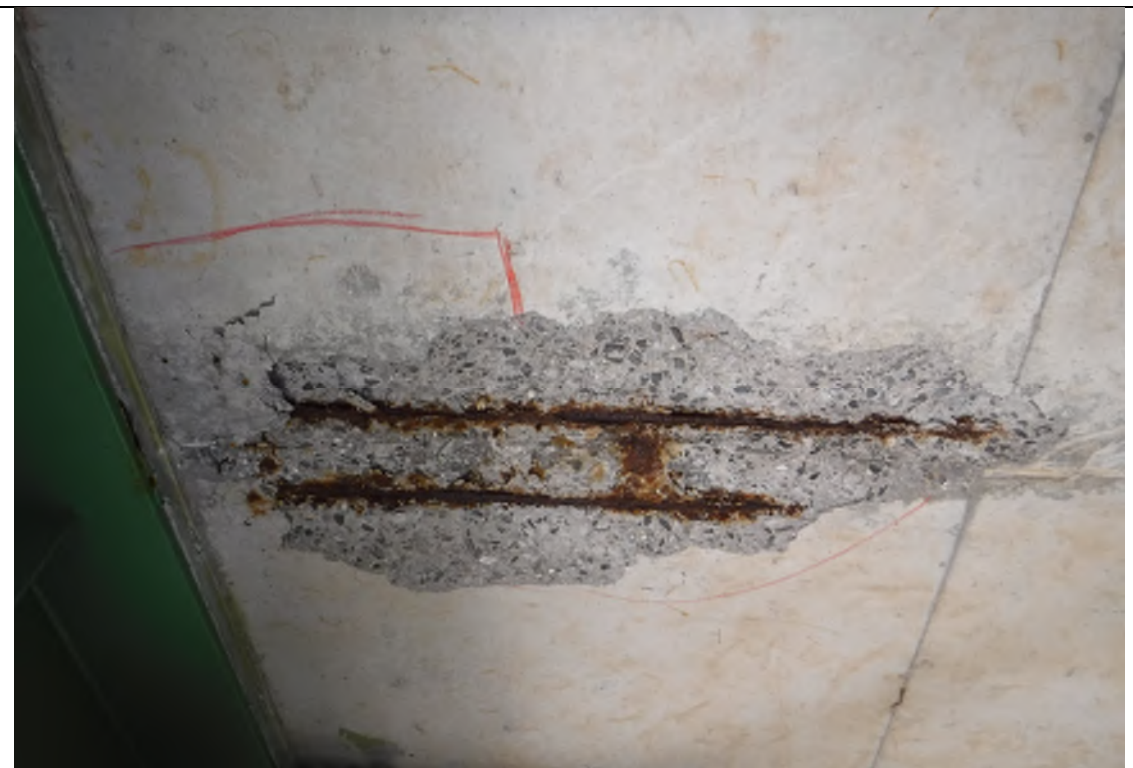
<b>PHOTO: 19</b>	<b>LOCATION:</b> <u>Span 7 Bay 11 (Joint) at pier 7</u> <b>DESCRIPTION:</b> <u>Underside of deck exhibits a 16 SF hollow area</u> <u>Looking East</u>

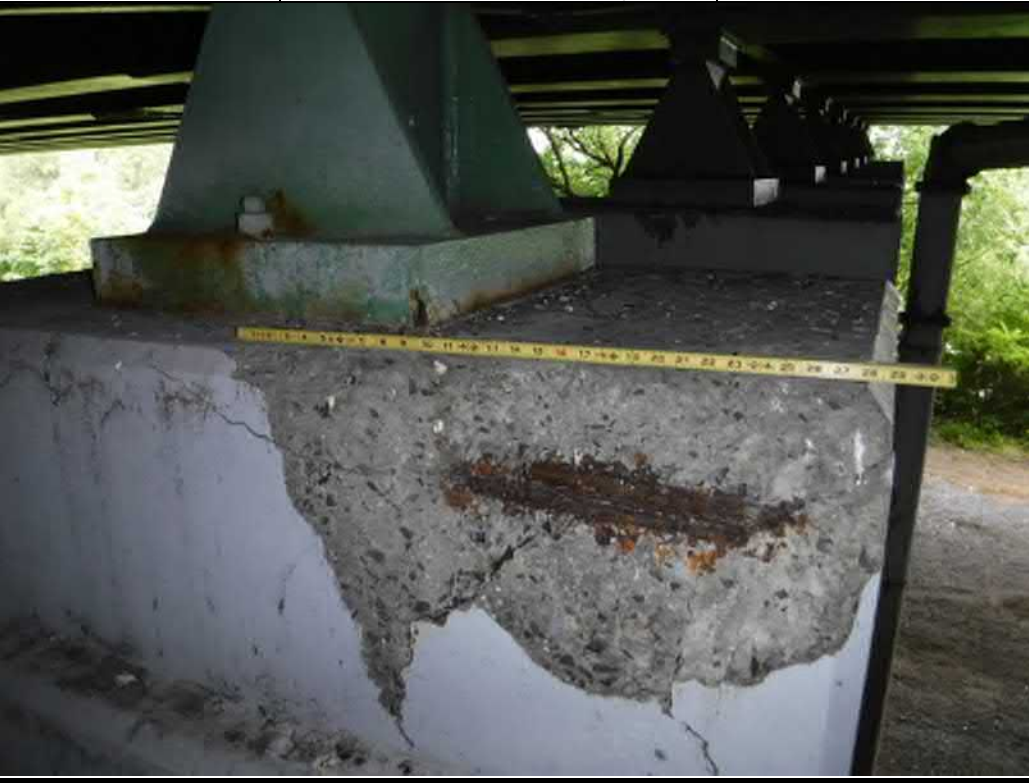
exposed rebar on the NW corner, Pier 3 pedestal 15 exhibits a 1 SF spall with exposed rebar on the North face, Pier 3 pedestal 7 exhibits a 4 LF cracks on the South and West face, Pier 3 North Pier underside exhibits a 16 SF spall with exposed rebar, Pier 6 South Pier cap exhibits several 3' long cracks on the West face, Pier 6 East face under pedestal 18 exhibits a 28 SF spall with exposed rebar, Pier 6 South pier cap underside exhibits a 10 SF spall with exposed rebar, Pier 6 East face pier cap exhibits multiple areas of 4 - 20 SF hollow areas, Pier 8 East face exhibits a 1 SF spall with exposed rebar under pedestal 6, Pier 8 North face of South pier cap exhibits a 6 SF spall with exposed rebar, Pier 9 span 10 side 2 SF spall with exposed rebar and hollow area along entire East face on pedestal 21, Pier 9 back side of pedestal 20 exhibits a 2 SF spall with exposed rebar, Pier 9 span 10 side pedestal 18 exhibits loss of entire North face with a 4 SF spall with exposed rebar, Pier 9 exhibits a 24 SF spall with exposed rebar at East face and underside, Pier 10 north pier underside exhibits a 7 SF spall with exposed rebar and a 40 SF hollow area surrounding, Pier 10 Ramp H side North face of pedestal 4 exhibits a 3 SF spall with exposed rebar, Pier 10 Ramp H side South face of pedestal 3 exhibits a 4 SF spall, Pier 12 span 12 side under pedestal 8 exhibits 2 SF spall with exposed rebar. (see photos 31 - 44).

<b>PHOTO: 31</b>	<b>LOCATION:</b> Pier 1 Span 1 side Pedestal 10 <b>DESCRIPTION:</b> Pedestal exhibits a 2 SF spall with exposed rebar and cracking. Looking South

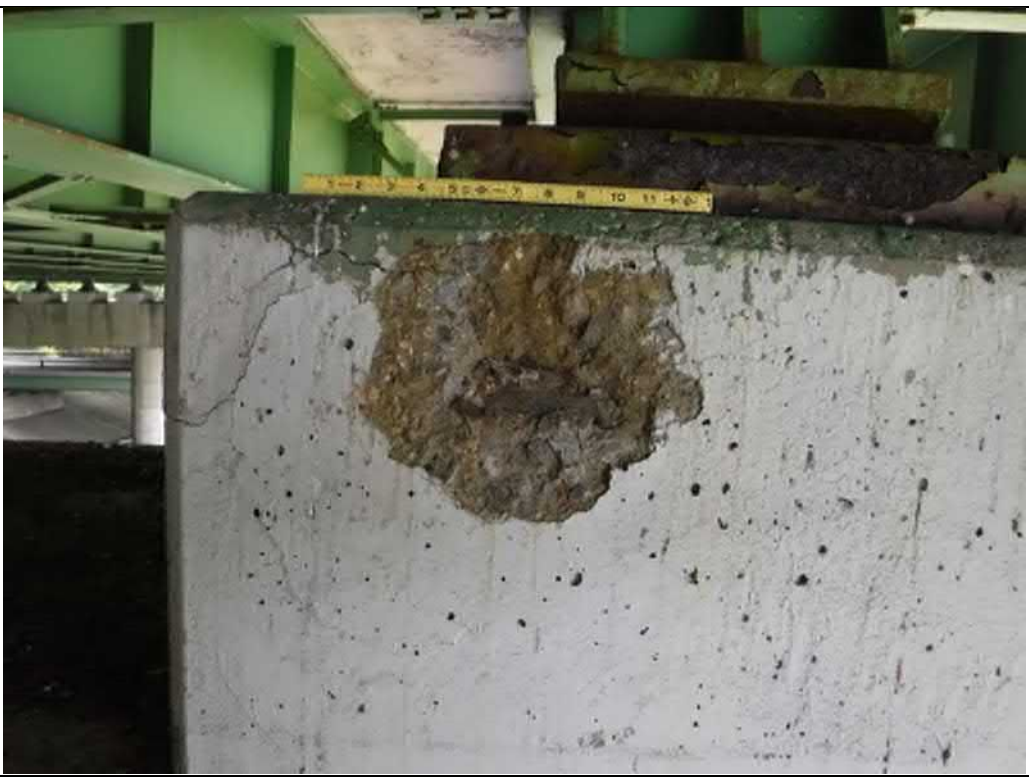
<b>PHOTO: 32</b>	<b>LOCATION:</b> Pier 3 Span 3 side Pedestal 15 <b>DESCRIPTION:</b> Pedestal exhibits a 1 SF spall with exposed rebar and cracking. Looking East

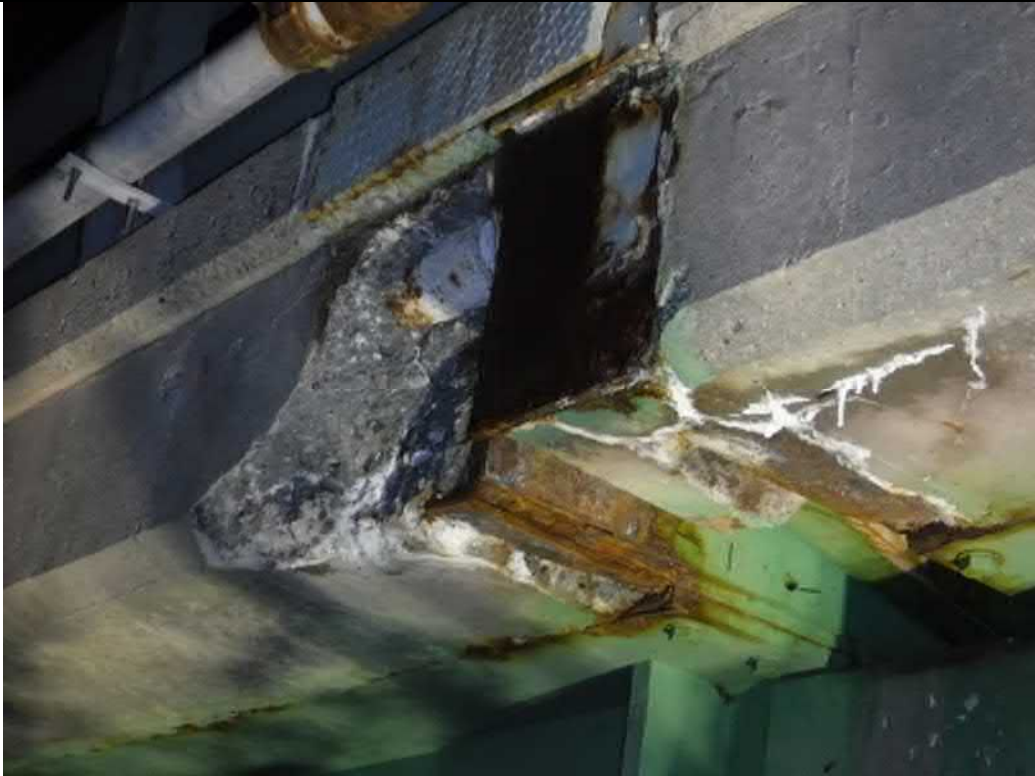
<b>PHOTO: 37</b>	<b>LOCATION:</b> Pier 6 South parapet <b>DESCRIPTION:</b> Parapet exhibits 4 SF spall Looking Northwest

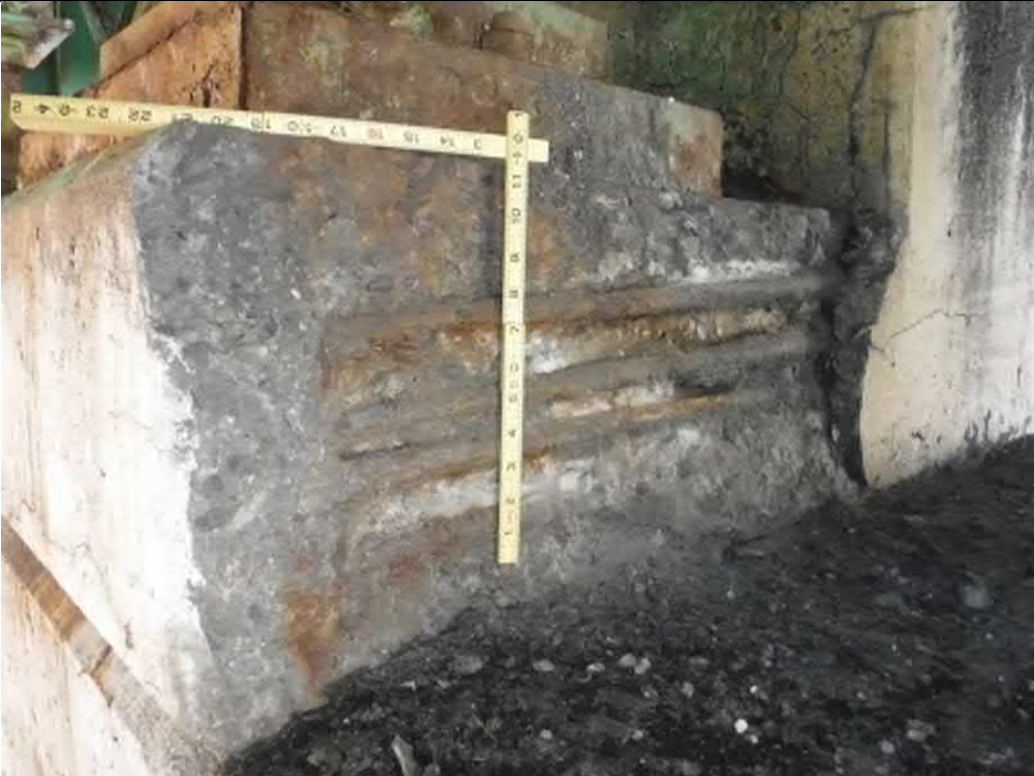
<b>PHOTO: 41</b>		
<b>LOCATION:</b> Pier 9 Span 10 side pedestal P18		
<b>DESCRIPTION:</b> Pedestal exhibits 4 SF spall with exposed rebar Looking Southwest

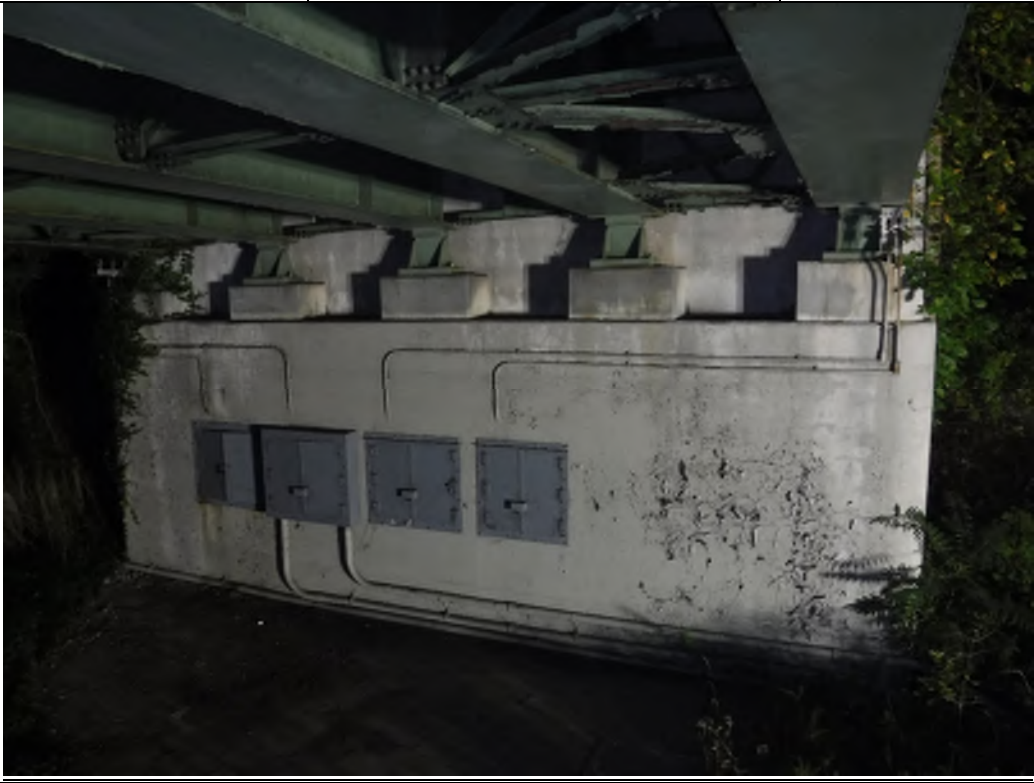
Ramp H abutment is in good condition and fully functional. The South face exhibits a 4 SF spall with cracking, the North face exhibits a 4 SF spall with exposed rebar. The North most electrical panel on the Ramp H abutment was partially open and unlocked. (see photos 53).

<b>PHOTO: 53</b>	<b>LOCATION:</b> Ramp H abutment <b>DESCRIPTION:</b> Abutment exhibits large map cracking on face Looking East

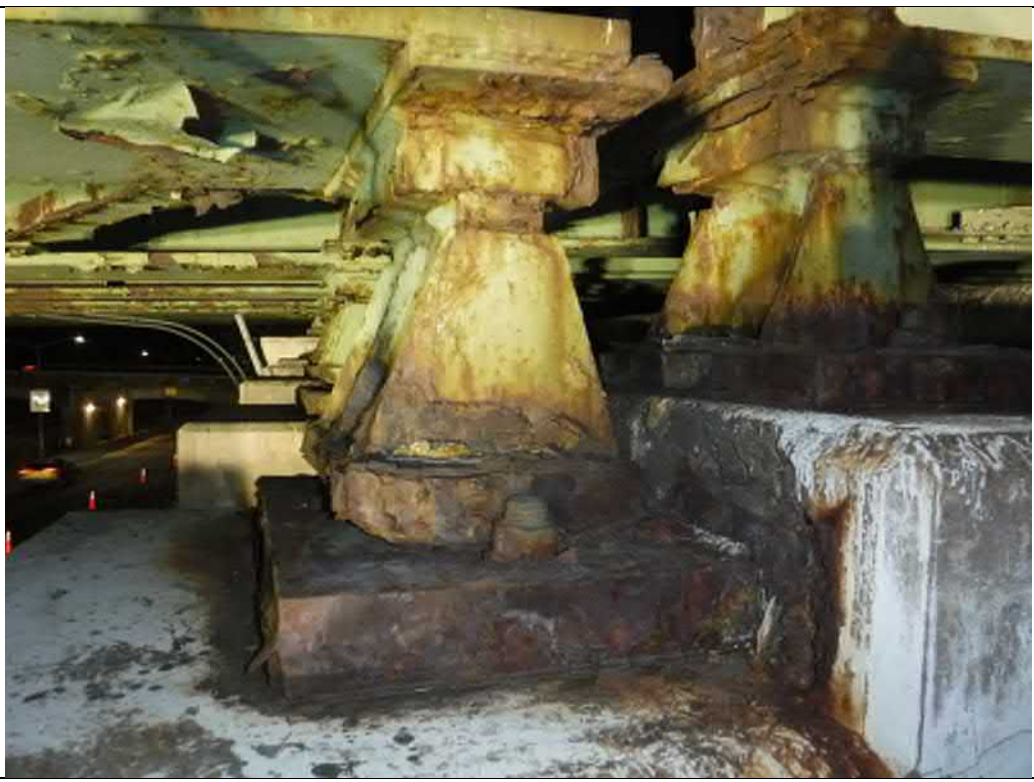
**Bearings:** The bearings at the West (Begin) abutment and piers 2, 3, 6, 7, 9, 10, 11, 12, 13 and the East (End) abutment are rocker bearings. The bearings at Pier 1, 5, 8 and 14 are fixed bearings. Each bearing is anchored to its pedestal with two, 1" diameter anchor bolts. Along the Begin abutment girder G1 bearing exhibits heavy pack rust which has frozen the bearing in place, along with deterioration of the anchor bolt nut. At pier 3 girder G15 bearing exhibits paint loss and pack rust. At pier 6, span 6 side, bearings vary from upright to tilting in expansion mode from 1 up to 6 degrees, on span 7 side bearings 5-7 show pack rust under curved edge of rocker. At pier 9 span 10 side, bearing G2 shows tilting in expansion mode about 4 degrees, bearing G14 exhibits heavy pack rust and paint chipping. At pier 9 bearing G1 shows tilting in expansion mode about 4 degrees, and heavy pack rust and paint chipping. At pier 10 Ramp H side bearings under G1 exhibit heavy pack rust and loss of paint. Pier 12 end bearings exhibit pack rust under curved plate. End (East) abutment exhibits loss of paint on bearings under G1, G10, G11, G12 and G17. (see photos 1 – 4 & 54).

<b>PHOTO: 54</b>	<b>LOCATION:</b> Span 10 bearing under girder G1 Ramp H side <b>DESCRIPTION:</b> Bearing exhibits heavy pack rust Looking South

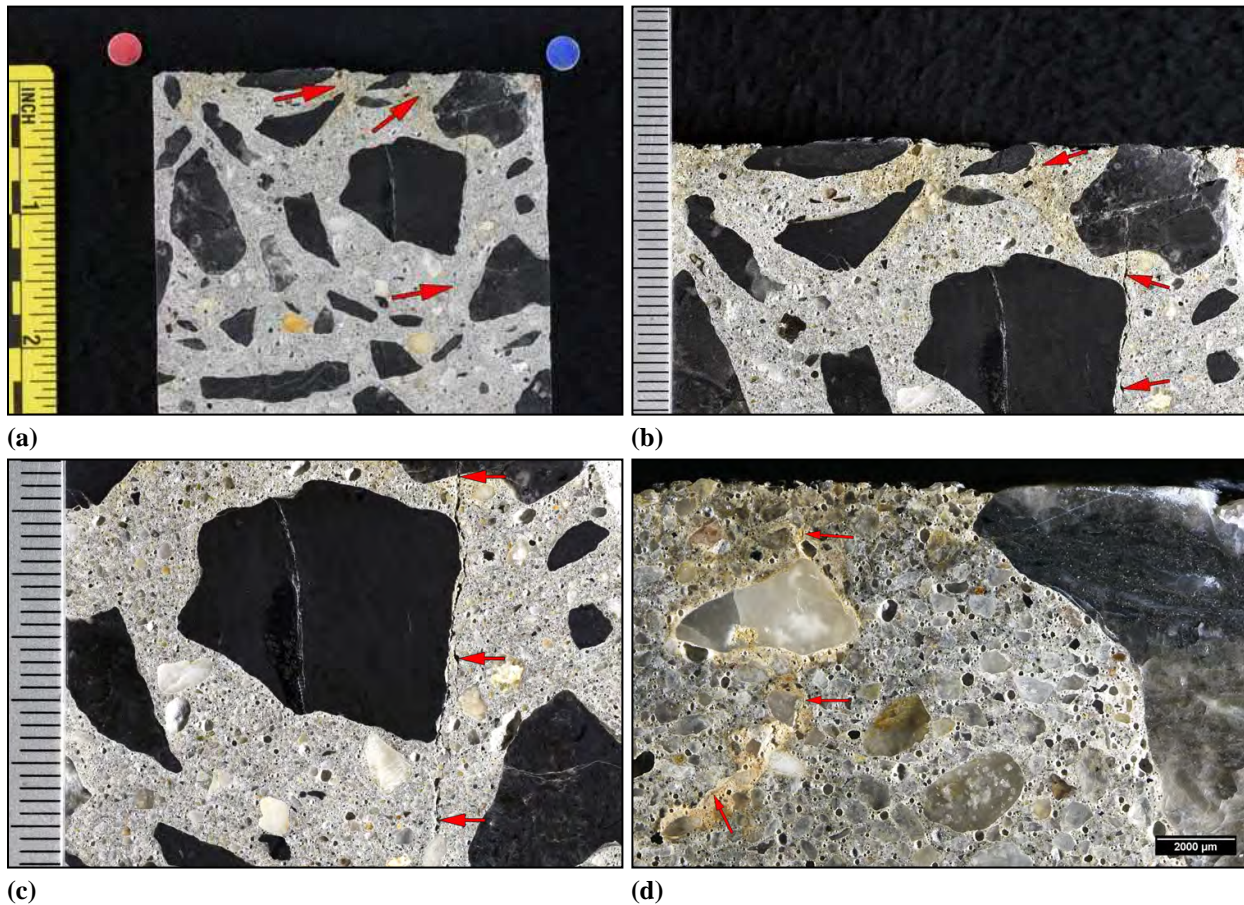
**Figure 4.** Images showing examples of sub-vertical cracks or microcracks in Core #14 and Core #21. (a) Photograph showing sub-vertical cracks (red arrows) on the polished surface of Core #14. Scale shows increments in inches. (b) Photograph showing detail of sub-vertical crack (red arrows) on the polished surface of Core #14. (b) Photograph showing sub-vertical crack (red arrows) detail below area shown in (b). Scale in (b) and (c) shows millimeter increments. (c) Reflected light photomicrograph showing sub-vertical microcrack (red arrows) on the polished surface of Core #21.

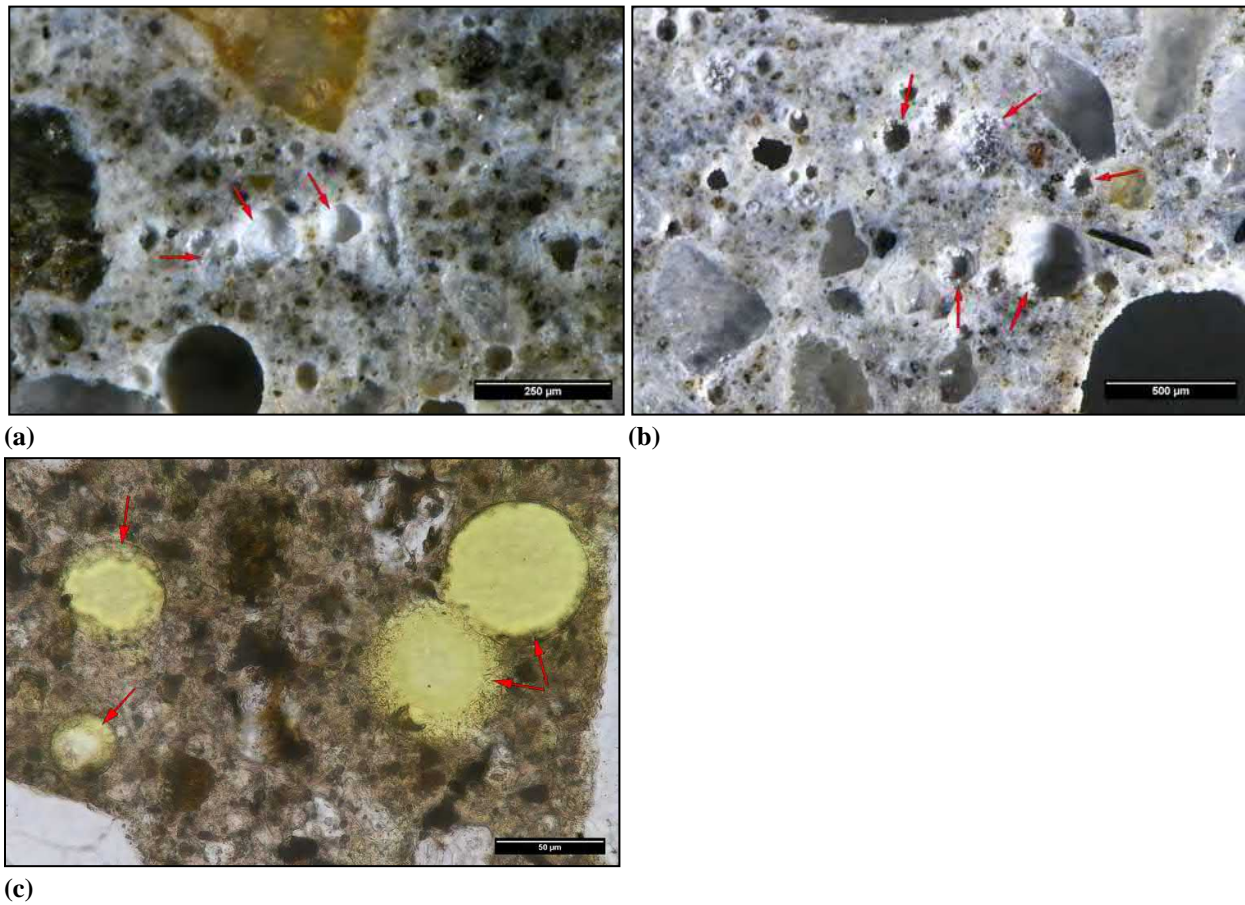
**Figure 10. Images showing examples of ettringite in voids. Reflected light photomicrographs of the polished surface of (a) Core #5 and (b) Core #19 showing white ettringite deposits (red arrows) in voids. (c) Plane-polarized transmitted light thin section photomicrograph showing ettringite (red arrows) in voids in Core #14.**

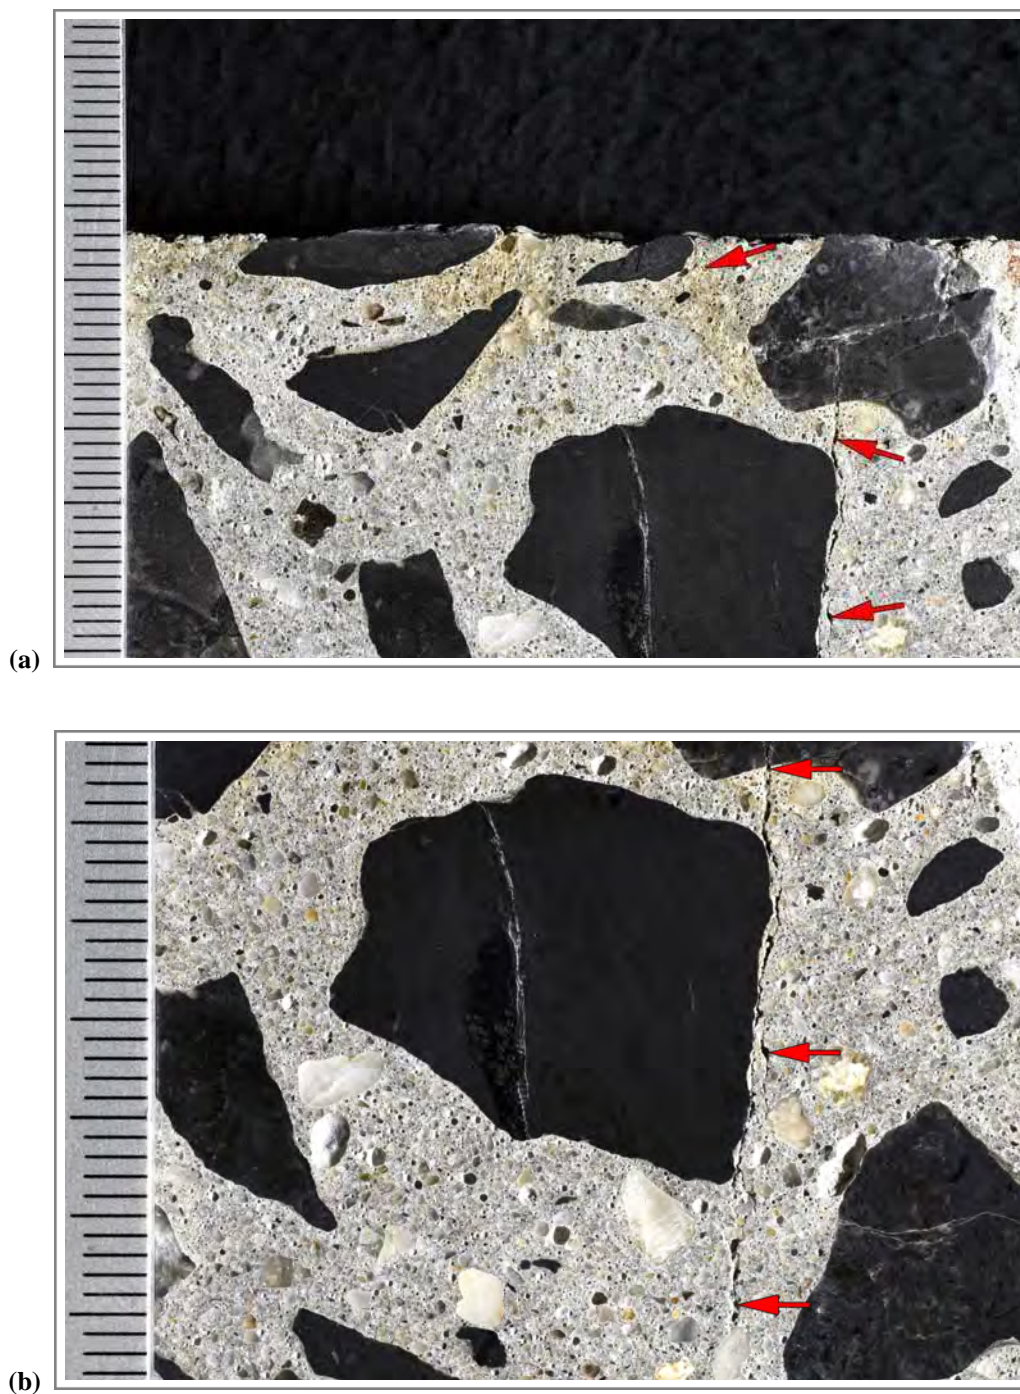
Figure C4. Photographs showing detail of sub-vertical crack (red arrows) in the top ~50 mm (2 in.) of the core. Scale in both images shows millimeter increments.

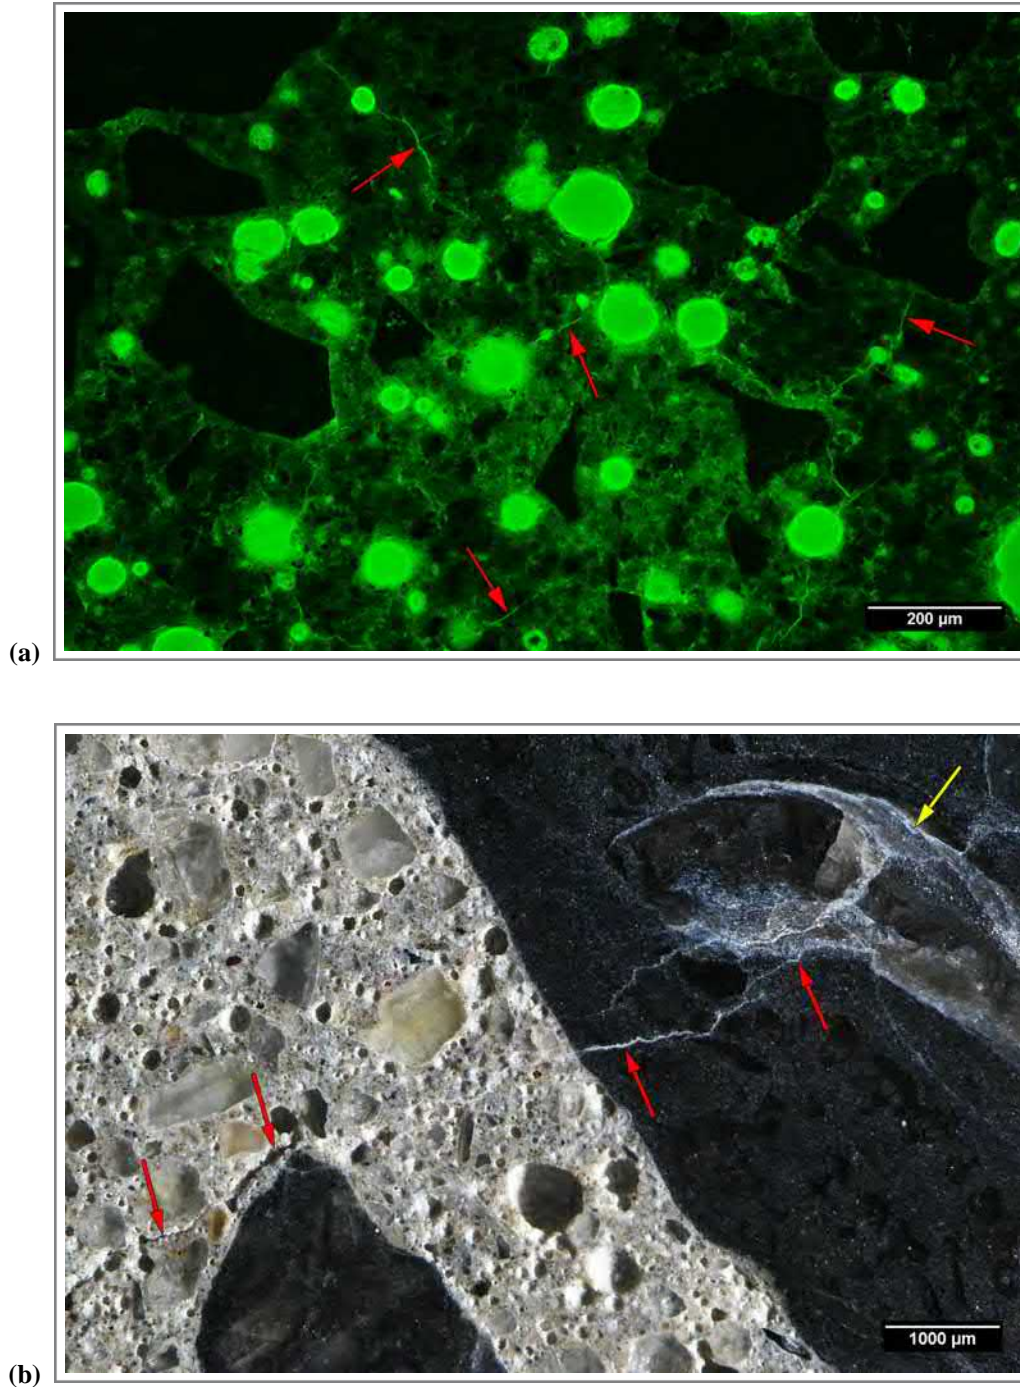
Figure C5. Images showing examples of microcracks in the core. (a) Transmitted fluorescent light thin section photomicrograph showing fine, randomly-oriented microcracks (red arrows) in the near-surface region of the core. (b) Reflected light photomicrograph showing detail of microcrack (red arrows) cutting from cherty portion of coarse aggregate particle into the paste.
